**Flood Control Project Maintenance  
Levee Inspections**

**Fall 2018 Levee Maintenance Deficiency Summary Report**

**Flood Control Project Maintenance  
Levee Inspections****LMA District Cover Sheet****Fall 2018 Levee Inspection Results****Levee District No. 0001 (Sutter County)**

**Levee District No. 0001 (Sutter County)**

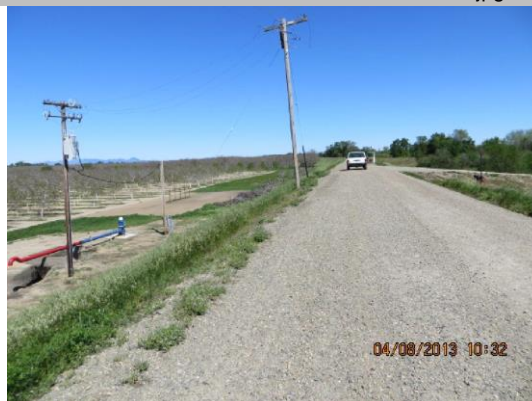
Photo 1 of 3 : UCIP\_FA\_2018\_41624\_18769.jpg

LM Start	0.36	Rating **	M	Issue No.	37	
LM End	0.36	Issue Type +	En	Location *		
Category	Supplemental			GPS Latitude/Longitude		
				Start	End	
Item	DWR UCIP Field Study			38.956192 °	38.956192 °	
				-121.585510 °	-121.585510 °	
DWR ID	18653

Comment Code						
Inspector Comment						
FS_ID:41624 DS_ID:18653 EP_NO: 4667 Repair Type: Non-Urgent Crossing Status: Found UCIP Comments: 04/12/2013 Abandoned crossing. Concrete box on both sides found. Pipe remainings are found on WS. (DWR UCIP - P. Amatya) FIELD_STRUCT_DESC: *ABANDONED* 36-inch steel irrigation pipe through the levee, 10 feet below the crown. Concrete box found on each side. Pipe remains found on the waterside (WS) after the removal of 40 feet of 36-inch steel pipe from a spur levee and 20 feet of 36-inch steel pipe from the landside (LS) slope of the Feather River Levee. (Plans for removal of a portion and filling with concrete a portion of an abandoned 36-inch steel pipe through the levee authorized under Permit No. 4667, 1964 - Levee District No. 1 of Sutter County [LD0001S])). [Additional Reference(s): USACE Sacramento O&M Manual 144, August 1955, (Station 735+57)]. FS Date: 4/12/2013

Crown view- overview of both sides of the levee

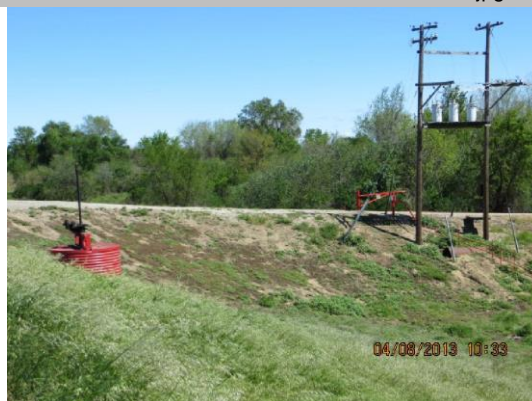
Photo 2 of 3 : UCIP\_FA\_2018\_41624\_18768.jpg

Comment Code						
Inspector Comment						
FS_ID:41624 DS_ID:18653 EP_NO: 4667 Repair Type: Non-Urgent Crossing Status: Found UCIP Comments: 04/12/2013 Abandoned crossing. Concrete box on both sides found. Pipe remainings are found on WS. (DWR UCIP - P. Amatya) FIELD_STRUCT_DESC: *ABANDONED* 36-inch steel irrigation pipe through the levee, 10 feet below the crown. Concrete box found on each side. Pipe remains found on the waterside (WS) after the removal of 40 feet of 36-inch steel pipe from a spur levee and 20 feet of 36-inch steel pipe from the landside (LS) slope of the Feather River Levee. (Plans for removal of a portion and filling with concrete a portion of an abandoned 36-inch steel pipe through the levee authorized under Permit No. 4667, 1964 - Levee District No. 1 of Sutter County [LD0001S]). [Additional Reference(s): USACE Sacramento O&M Manual 144, August 1955, (Station 735+57)]. FS Date: 4/12/2013

WS- abandoned pipe near power pole (right)

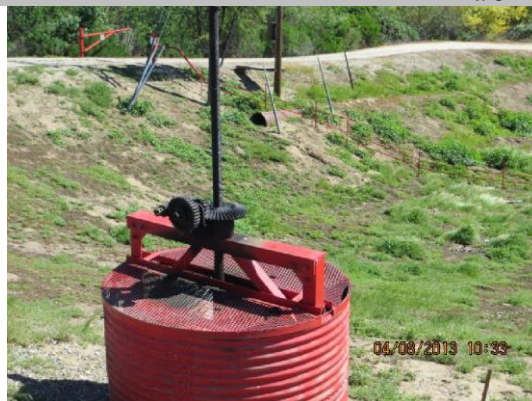
Photo 3 of 3 : UCIP\_FA\_2018\_41624\_18767.jpg

WS- abandoned pipe near power pole (top)

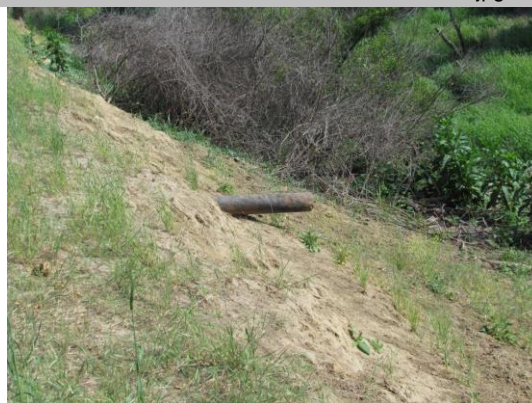
Photo 1 of 3 : UCIP\_FA\_2018\_53068\_75107.jpg

Comment Code						
Inspector Comment						
FS_ID:53068 DS_ID:17917 EP_NO: N/A Repair Type: Non-Urgent Crossing Status: Not Found UCIP Comments: 10/15/2018 Pipe not found. Pipe removed as part of the Project Area A Feather River West Levee Project. Contacted LMA to obtain as-built drawings showing the pipe removal through the levee. Crossing has been downgraded from Urgent to Non-Urgent, waiting to receive as-built drawings pertaining to levee improvement project for this section of the levee. (O. Magana - DWR UCIP)07/20/2016 Same as previous comment, although pipe is open on the waterside (WS) and capped on the LS. Note that this section of levee will likely be reconstructed as part of Project Area A of the Feather River West Levee Project (Star Bend to Sutter Bypass). (K. Fazel - UCIP)05/23/2016 Needs proper abandonment; pipe open on both ends (courtesy of Sterling York, DWR Inspector). (K. Fazel - UCIP) FIELD_STRUCT_DESC: *REMOVED* 8-inch steel pipe of an unknown purpose through the levee, 4.6 feet below the crown. Siphon breaker in a 24-inch corrugated metal pipe (CMP) riser on the landside (LS) shoulder, not found in 2016. [Additional Reference(s): DWR Levee Log, 2005. USACE Sacramento O&M Manual 144, August 1955, (Station 657+00), As-Built Drawing No. 4-4-205-1]. FS Date: 10/16/2018

Pipe visible on WS slope. Photo courtesy of Sterling York, DWR Inspector.

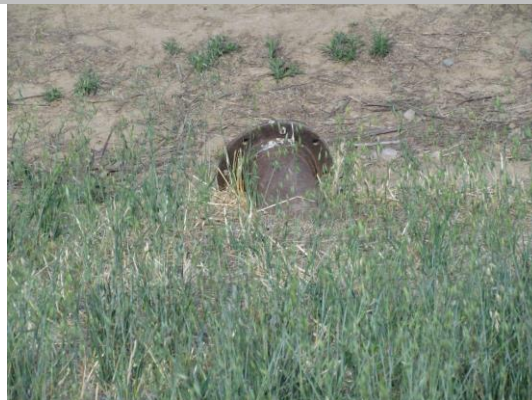
Photo 2 of 3 : UCIP\_FA\_2018\_53068\_75108.jpg

Comment Code						
Inspector Comment						
FS_ID:53068 DS_ID:17917 EP_NO: N/A Repair Type: Non-Urgent Crossing Status: Not Found UCIP Comments: 10/15/2018 Pipe not found. Pipe removed as part of the Project Area A Feather River West Levee Project. Contacted LMA to obtain as-built drawings showing the pipe removal through the levee. Crossing has been downgraded from Urgent to Non-Urgent, waiting to receive as-built drawings pertaining to levee improvement project for this section of the levee. (O. Magana - DWR UCIP)07/20/2016 Same as previous comment, although pipe is open on the waterside (WS) and capped on the LS. Note that this section of levee will likely be reconstructed as part of Project Area A of the Feather River West Levee Project (Star Bend to Sutter Bypass). (K. Fazel - UCIP)05/23/2016 Needs proper abandonment; pipe open on both ends (courtesy of Sterling York, DWR Inspector). (K. Fazel - UCIP) FIELD_STRUCT_DESC: *REMOVED* 8-inch steel pipe of an unknown purpose through the levee, 4.6 feet below the crown. Siphon breaker in a 24-inch corrugated metal pipe (CMP) riser on the landside (LS) shoulder, not found in 2016. [Additional Reference(s): DWR Levee Log, 2005. USACE Sacramento O&M Manual 144, August 1955, (Station 657+00), As-Built Drawing No. 4-4-205-1]. FS Date: 10/16/2018

Pipe open on LS end. Photo courtesy of Sterling York, DWR Inspector.

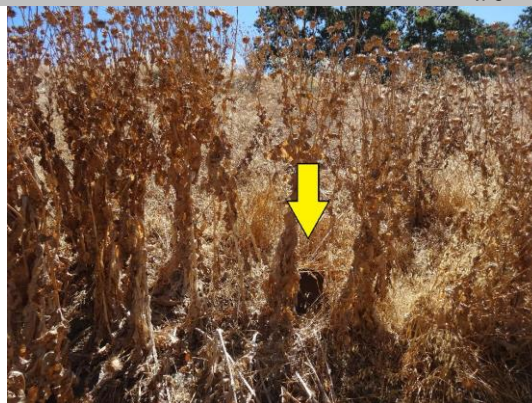
Photo 3 of 3 : UCIP\_FA\_2018\_53068\_76120.jpg

LM Start	<b>1.85</b>	Rating **	M	Issue No.	<b>38 (cont)</b>
LM End	<b>1.85</b>	Issue Type +	En	Location *

LS view: pipe appears to be capped, though in a rudimentary fashion.

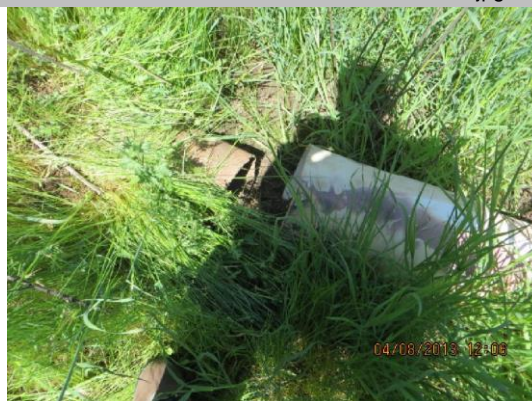
Photo 1 of 3 : UCIP\_FA\_2018\_11383\_18782.jpg

LM Start	2.21	Rating **	M	Issue No.	39	
LM End	2.21	Issue Type +	En	Location *		
Category	Supplemental			GPS Latitude/Longitude		
				Start	End	
Item	DWR UCIP Field Study			38.982135 °	38.982135 °	
				-121.591974 °	-121.591974 °	
DWR ID	17915					
Comment Code						
Inspector Comment						
FS_ID:11383 DS_ID:17915 EP_NO: N/A Repair Type: Non-Urgent Crossing Status: Found UCIP Comments: 04/12/2013 Siphon breaker cap missing. Sump pump and gate valve at landward toe not found may be due to dense vegetation. (DWR UCIP - P. Amatya) FIELD_STRUCT_DESC: 8-inch coated steel pipe of an unknown purpose through the levee, 4.6 feet below the crown. Siphon breaker in a corrugated metal pipe (CMP) riser on the landside (LS) slope. [Additional Reference(s): DWR Levee Log, 2005. USACE Sacramento O&M Manual 144, August 1955, (Station 638+07)]. FS Date: 4/12/2013

WS- 8-inch steel pipe and disconnected pvc pipe on levee slope

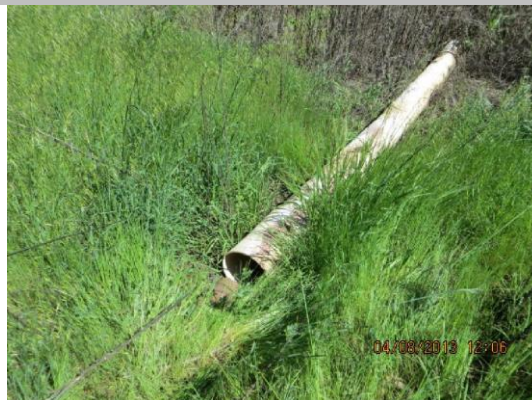
Photo 2 of 3 : UCIP\_FA\_2018\_11383\_18781.jpg

WS-a disconnected pvc pipe on levee slope

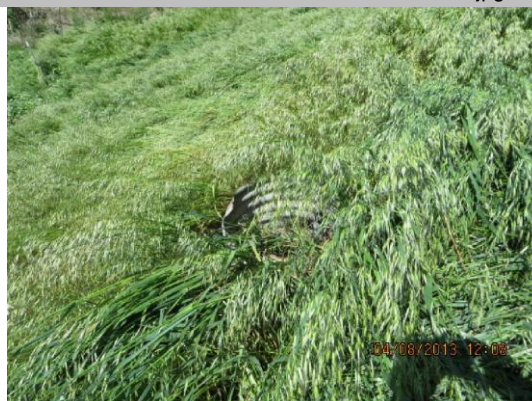
Photo 3 of 3 : UCIP\_FA\_2018\_11383\_18780.jpg

Comment Code						
Inspector Comment						
FS_ID:11383						
DS_ID:17915						
EP_NO: N/A						
Repair Type: Non-Urgent						
Crossing Status: Found						
UCIP Comments: 04/12/2013 Siphon breaker cap missing. Sump pump and gate valve at landward toe not found may be due to dense vegetation. (DWR UCIP - P. Amatya)						
FIELD_STRUCT_DESC: 8-inch coated steel pipe of an unknown purpose through the levee, 4.6 feet below the crown. Siphon breaker in a corrugated metal pipe (CMP) riser on the landside (LS) slope.						
[Additional Reference(s): DWR Levee Log, 2005. USACE Sacramento O&M Manual 144, August 1955, (Station 638+07)].						
FS Date: 4/12/2013

LS- CMP riser on levee slope with dense vegetation.

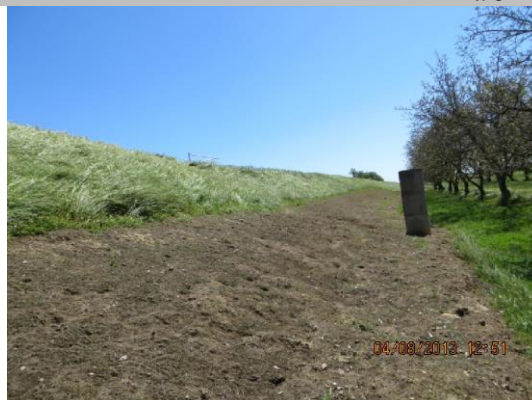
Photo 1 of 3 : UCIP\_FA\_2018\_41787\_18793.jpg

LM Start	2.42	Rating **	M	Issue No.	40
LM End	2.42	Issue Type +	En	Location *	
Category	Supplemental			GPS Latitude/Longitude	
				Start	End
Item	DWR UCIP Field Study			38.985223 °	38.985223 °
				-121.591922 °	-121.591922 °
DWR ID	18667

Comment Code					
Inspector Comment					
FS_ID:41787 DS_ID:18667 EP_NO: N/A Repair Type: Non-Urgent Crossing Status: Found UCIP Comments: 04/12/2013 Pipe appears to be abandoned and should be verified as having been done so properly. - concrete standpipe with 10-inch steel pipe.- concrete wing wall- no pipe-abandoned structure- a pump found on other side of the levee (WS) but not sure whether it is associated with this crossing. (DWR UCIP - P. Amatya) FIELD_STRUCT_DESC: *ABANDONED* 24-inch gravity drainage pipe of an unknown material under the landside (LS) approach, at an unknown depth. Plans to install a 10-inch corrugated iron gravity drainage culvert under the LS approach, at an unknown depth. Crossing not found in the O&M Manual. FS Date: 4/12/2013

LS- overview of landside with concrete standpipe

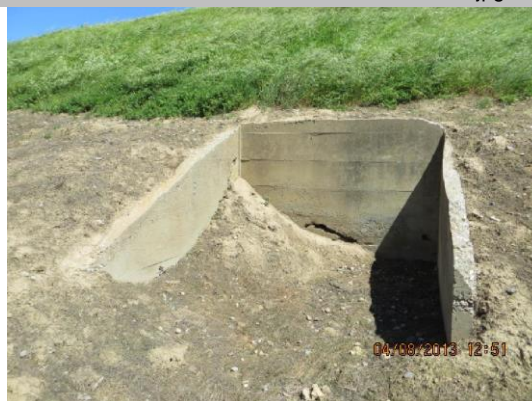
Photo 2 of 3 : UCIP\_FA\_2018\_41787\_18792.jpg

Comment Code						
Inspector Comment						
FS_ID:41787 DS_ID:18667 EP_NO: N/A Repair Type: Non-Urgent Crossing Status: Found UCIP Comments: 04/12/2013 Pipe appears to be abandoned and should be verified as having been done so properly. - concrete standpipe with 10-inch steel pipe.- concrete wing wall- no pipe- abandoned structure- a pump found on other side of the levee (WS) but not sure whether it is associated with this crossing. (DWR UCIP - P. Amatya) FIELD_STRUCT_DESC: *ABANDONED* 24-inch gravity drainage pipe of an unknown material under the landside (LS) approach, at an unknown depth. Plans to install a 10-inch corrugated iron gravity drainage culvert under the LS approach, at an unknown depth. Crossing not found in the O&M Manual. FS Date: 4/12/2013

LS- abandoned wing wall- no pipe

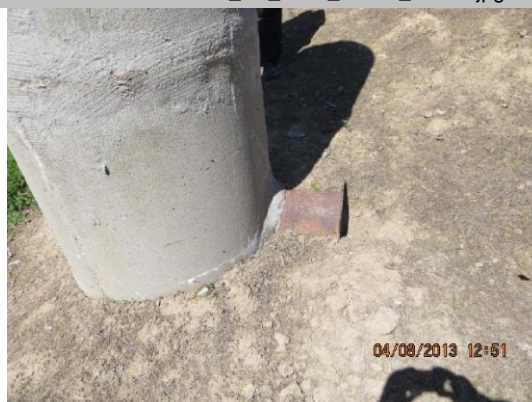
Photo 3 of 3 : UCIP\_FA\_2018\_41787\_18791.jpg

LS- concrete standpipe with disconnected steel pipe

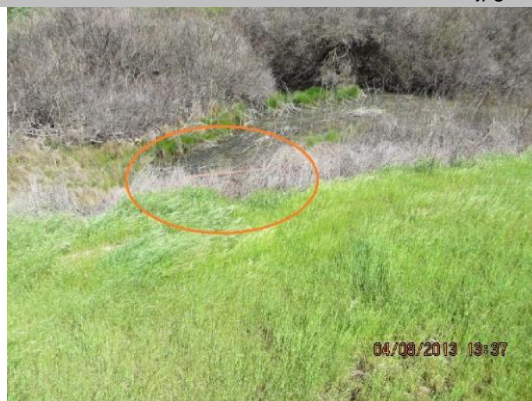
Photo 2 of 3 : UCIP\_FA\_2018\_41348\_18881.jpg

Comment Code						
Inspector Comment						
FS_ID:41348						
DS_ID:17918						
EP_NO: N/A						
Repair Type: Non-Urgent						
Crossing Status: Indicator Found						
UCIP Comments: 04/08/2013 Only an abandoned steel structure on water and a concrete structure on WS Levee slope found. Need to verify pipe was properly abandoned. (DWR UCIP - P. Amatya)						
FIELD_STRUCT_DESC: *ABANDONED* 8-inch steel pipe of an unknown purpose through the levee, 4.1 feet below the crown. Siphon breaker on the landside (LS) slope. Butterfly shutoff valve on the LS slope. Concrete standpipe and pump at the LS toe. Pipe discharges into borrow pit on the waterside (WS). [Additional Reference(s): DWR Levee Log, 2005. USACE Sacramento O&M Manual 144, August 1955, (Station 574+20)].						
FS Date: 4/8/2013

WS- abandoned steel structure on waterway

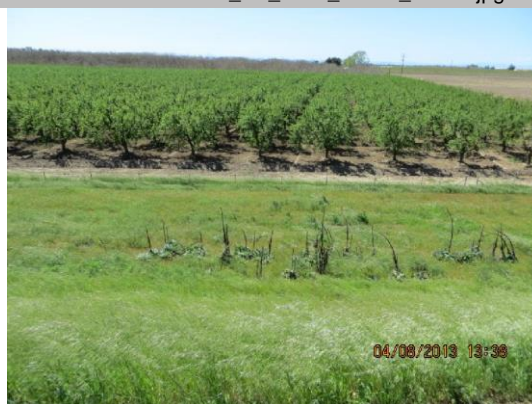
Photo 3 of 3 : UCIP\_FA\_2018\_41348\_18880.jpg

Overview of landside of the levee- no pipes visible. Dense vegetation.

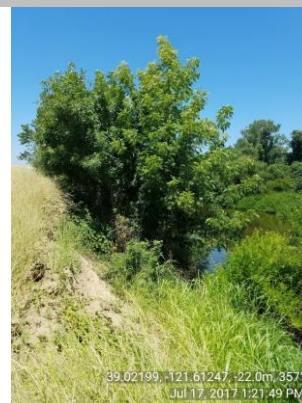
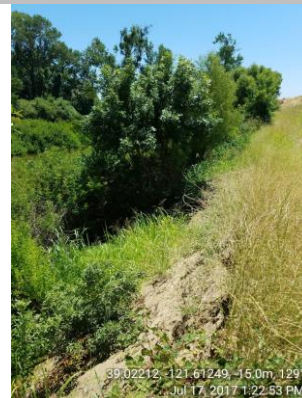
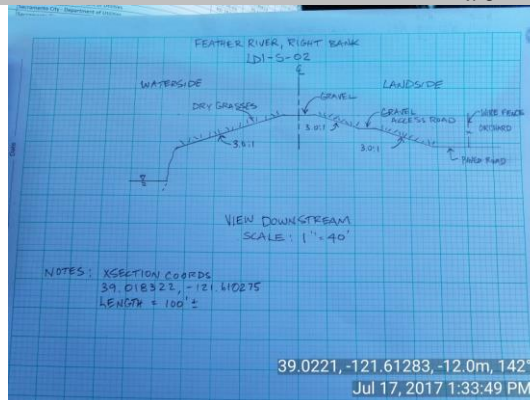
LM Start	5.02	Rating **	A/W	Issue No.	25	
LM End	5.02	Issue Type +	Ma	Location *		
Category	Supplemental			GPS Latitude/Longitude		
				Start		End
Item	2017 Storm Damage			39.018322 °	39.018322 °	
				-121.610275 °	-121.610275 °	
DWR ID	DWR_LD0001S_01_f_2017_25					
Comment Code						
Inspector Comment						
Levee Evaluation Comments						
Description:						
Site ID No:145						
Site Designation:LD1-S-02						
Repair Type: Erosion						
Rating:Critical						
Field Date:7/17/2017						
Notes:

LM Start	5.02	Rating **	A/W	Issue No.	25 (cont)	
LM End	5.02	Issue Type +	Ma	Location *		
Category	Supplemental			GPS Latitude/Longitude		
				Start	End	
Item	2017 Storm Damage			39.018322 °	39.018322 °	
				-121.610275 °	-121.610275 °	
DWR ID	DWR_LD0001S_01_f_2017_25					
Comment Code						
Inspector Comment						
Levee Evaluation Comments						
Description:						
Site ID No:145						
Site Designation:LD1-S-02						
Repair Type: Erosion						
Rating:Critical						
Field Date:7/17/2017						
Notes:

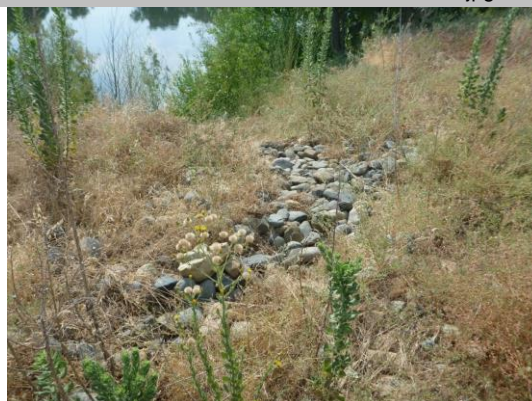
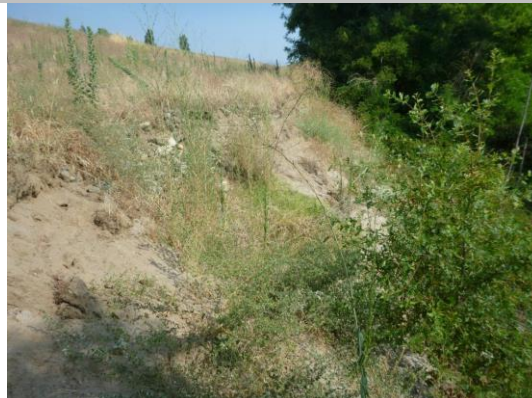
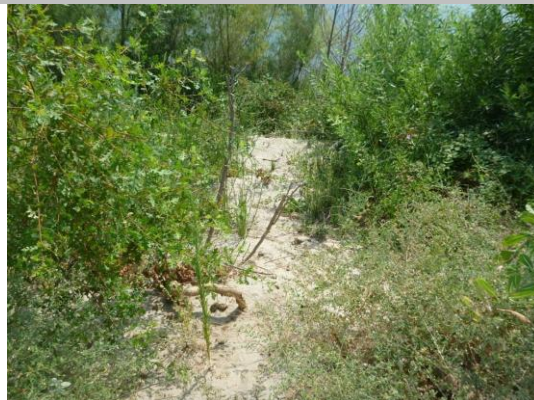
LM Start	7.69	Rating **	A/W	Issue No.	19
LM End	7.74	Issue Type +	Ma	Location *	
Category	Supplemental			GPS Latitude/Longitude	
				Start	End
Item	2017 Storm Damage			39.055986°	39.056710°
				-121.611301°	-121.611331°
DWR ID	DWR_LD0001S_01_f_2017_19				
Comment Code					
Inspector Comment					
Levee Evaluation Comments					
Description:					
Site ID No:146					
Site Designation:LD1-S-03					
Repair Type: Erosion					
Rating:Area of Concern					
Field Date:8/3/2017					
Notes:

LM Start	7.69	Rating **	A/W	Issue No.	19 (cont)	
LM End	7.74	Issue Type +	Ma	Location *		
Category	Supplemental			GPS Latitude/Longitude		
				Start	End	
Item	2017 Storm Damage			39.055986 °	39.056710 °	
				-121.611301 °	-121.611331 °	
DWR ID	DWR_LD0001S_01_f_2017_19					
Comment Code						
Inspector Comment						
Levee Evaluation Comments						
Description:						
Site ID No:146						
Site Designation:LD1-S-03						
Repair Type: Erosion						
Rating:Area of Concern						
Field Date:8/3/2017						
Notes:

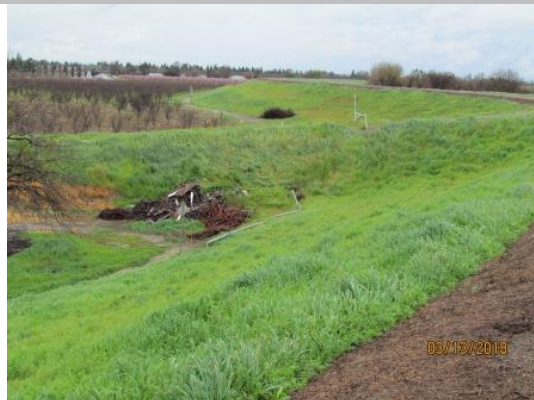
Photo 1 of 2 : FA\_2018\_LD0001S\_433\_23\_20180918\_00005.jpg

LM Start	9.35	Rating **	M	Issue No.	23
LM End	9.35	Issue Type +	En	Location *	LS
Category	Earthen Levee			GPS Latitude/Longitude	
				Start	End
Item	Encroachments			39.079026 °	39.079026 °
				-121.604386 °	-121.604386 °
DWR ID	DWR_LD0001S_01_f_2015_23				
Comment Code					
PR : Prunings					
Inspector Comment					
Tree trimmings and debris still exist at landside toe that are within 10' of the toe need to be removed, Fall 2018.

View of prunings that still exist on the landside levee toe. Spring 2018.

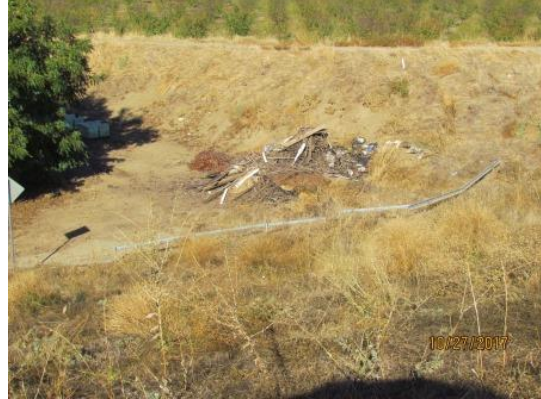
Photo 2 of 2 : FA\_2018\_LD0001S\_433\_23\_20180918\_00006.jpg

View of prunings on the landside levee toe. Fall 2017.

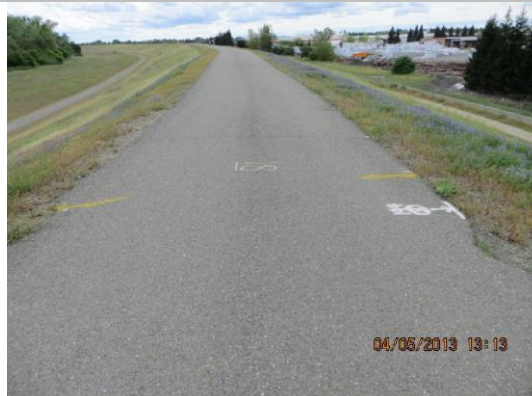
Photo 1 of 3 : UCIP\_FA\_2018\_41841\_19538.jpg

LM Start	11.99	Rating **	M	Issue No.	42	
LM End	11.99	Issue Type +	En	Location *		
Category	Supplemental			GPS Latitude/Longitude		
				Start	End	
Item	DWR UCIP Field Study			39.114856 °	39.114856 °	
				-121.605821 °	-121.605821 °	
DWR ID	17932					
Comment Code						
Inspector Comment						
FS_ID:41841 DS_ID:17932 EP_NO: N/A Repair Type: Non-Urgent Crossing Status: Indicator Found UCIP Comments: 04/05/2013 Need to install Gasline Markers.Fenced control station.Indicator on LS across concrete ditch.Found road markings.(DWR UCIP - P. Amatya) FIELD_STRUCT_DESC: 1 of 2: 16-inch natural gas pipeline of an unknown material through the levee, 3 feet below the crown. PG&E gas line crossing sign on the waterside (WS) shoulder. [Additional Reference(s): DWR Levee Log, 2005]. FS Date: 4/5/2013

Levee Crown: gasline indicator/markings on crown road.

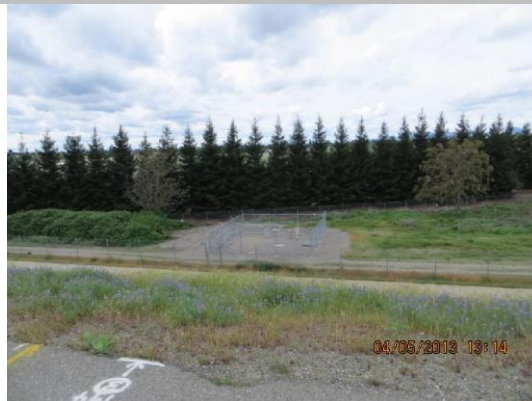
Photo 2 of 3 : UCIP\_FA\_2018\_41841\_19537.jpg

LS- fenced control station across concrete ditch

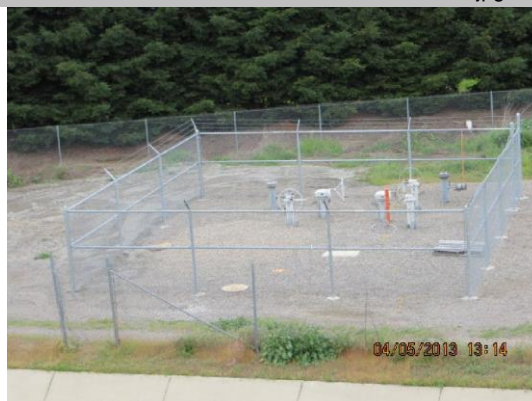
Photo 3 of 3 : UCIP\_FA\_2018\_41841\_19534.jpg

LM Start	11.99	Rating **	M	Issue No.	42 (cont)
LM End	11.99	Issue Type +	En	Location *	
Category	Supplemental			GPS Latitude/Longitude	
				Start	End
Item	DWR UCIP Field Study			39.114856 °	39.114856 °
				-121.605821 °	-121.605821 °
DWR ID	17932				
Comment Code					
Inspector Comment					
FS_ID:41841 DS_ID:17932 EP_NO: N/A Repair Type: Non-Urgent Crossing Status: Indicator Found UCIP Comments: 04/05/2013 Need to install Gasline Markers.Fenced control station.Indicator on LS across concrete ditch.Found road markings.(DWR UCIP - P. Amatya) FIELD_STRUCT_DESC: 1 of 2: 16-inch natural gas pipeline of an unknown material through the levee, 3 feet below the crown. PG&E gas line crossing sign on the waterside (WS) shoulder. [Additional Reference(s): DWR Levee Log, 2005]. FS Date: 4/5/2013

LS- fenced control station with indicators

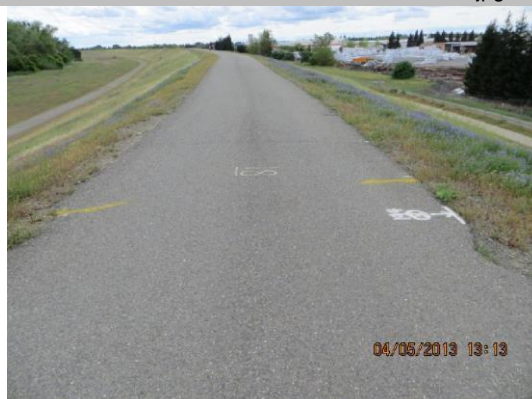
Photo 1 of 3 : UCIP\_FA\_2018\_41889\_19566.jpg

LM Start	12.00	Rating **	M	Issue No.	43
LM End	12.00	Issue Type +	En	Location *	
Category	Supplemental			GPS Latitude/Longitude	
				Start	End
Item	DWR UCIP Field Study			39.114856 °	39.114856 °
				-121.605821 °	-121.605821 °
DWR ID	18880				
Comment Code					
Inspector Comment					
FS_ID:41889 DS_ID:18880 EP_NO: N/A Repair Type: Non-Urgent Crossing Status: Indicator Found UCIP Comments: 04/05/2013 Need to contact owner to install gasline markers.Fenced control station on LS.Indicator on LS across concrete channel.Road markings. (DWR UCIP - P. Amatya) FIELD_STRUCT_DESC: 2 of 2: 16-inch natural gas pipeline of an unknown material through the levee, 3 feet below the crown. PG&E gas line crossing sign on the waterside (WS) shoulder. [Additional Reference(s): DWR Levee Log, 2005]. FS Date: 4/5/2013

Levee Crown: road markings on road pavement

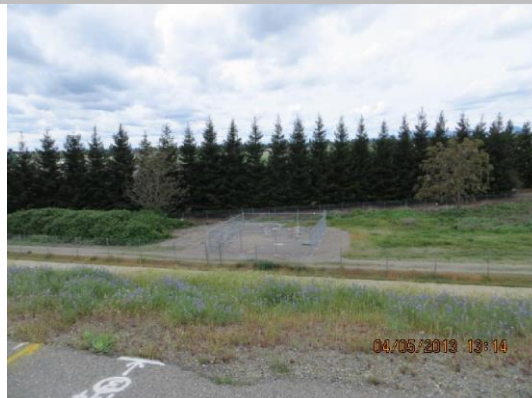
Photo 2 of 3 : UCIP\_FA\_2018\_41889\_19565.jpg

LM Start	12.00	Rating **	M	Issue No.	43 (cont)	
LM End	12.00	Issue Type +	En	Location *		
Category	Supplemental			GPS Latitude/Longitude		
				Start	End	
Item	DWR UCIP Field Study			39.114856 °	39.114856 °	
				-121.605821 °	-121.605821 °	
DWR ID	18880					
Comment Code						
Inspector Comment						
FS_ID:41889 DS_ID:18880 EP_NO: N/A Repair Type: Non-Urgent Crossing Status: Indicator Found UCIP Comments: 04/05/2013 Need to contact owner to install gasoline markers. Fenced control station on LS. Indicator on LS across concrete channel. Road markings. (DWR UCIP - P. Amatya) FIELD_STRUCT_DESC: 2 of 2: 16-inch natural gas pipeline of an unknown material through the levee, 3 feet below the crown. PG&E gas line crossing sign on the waterside (WS) shoulder. [Additional Reference(s): DWR Levee Log, 2005]. FS Date: 4/5/2013

LS- fenced control station across concrete ditch.

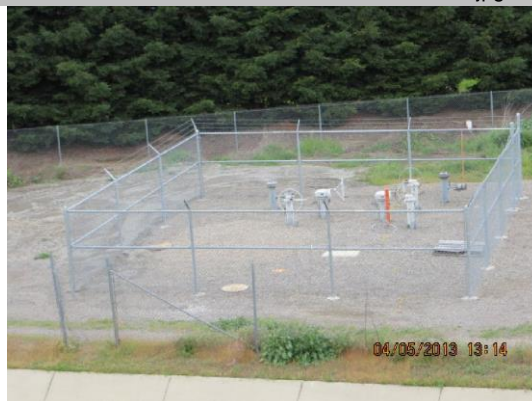
Photo 3 of 3 : UCIP\_FA\_2018\_41889\_19564.jpg

LS- fenced control station with gasoline indicator across concrete ditch.

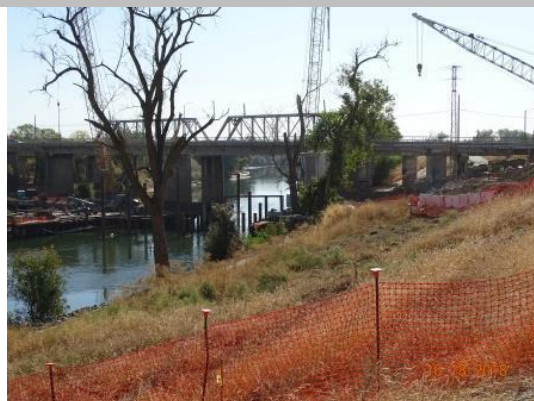
Photo 2 of 2 : FA\_2018\_LD0001S\_433\_26\_20181108\_00059.jpg

LM Start	13.87	Rating **	A/W	Issue No.	26 (cont)	
LM End	13.87	Issue Type +	Ma	Location *	CR	
Category	Earthen Levee			GPS Latitude/Longitude		
				Start		End
Item	Crown Surface / Depressions / Rutting			39.139734 °		39.139734 °
				-121.608477 °		-121.608477 °
DWR ID	DWR_LD0001S_01_f _ 2018_26					
Comment Code						
C2 : Repair depressions or ruts in the crown or slope.						
Inspector Comment						
Fifth Street Bridge Construction, Fall 2018.

View looking downstream waterside of the 5th Street bridge construction, Fall 2018.

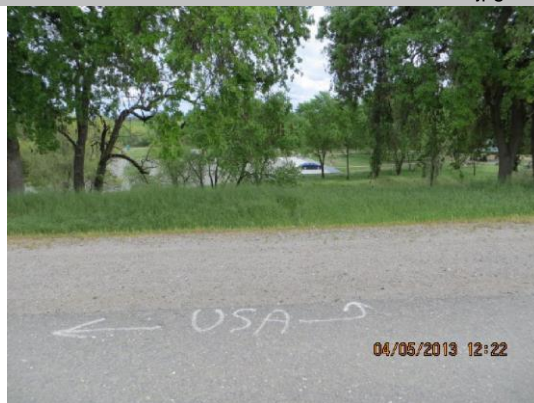
Photo 1 of 3 : UCIP\_FA\_2018\_41887\_19571.jpg

LM Start	14.35	Rating **	M	Issue No.	44
LM End	14.35	Issue Type +	En	Location *	
Category	Supplemental			GPS Latitude/Longitude	
				Start	End
Item	DWR UCIP Field Study			39.146494 °	39.146494 °
				-121.609715 °	-121.609715 °
DWR ID	18640

Comment Code					
Inspector Comment					
FS_ID:41887					
DS_ID:18640					
EP_NO: N/A					
Repair Type: Non-Urgent					
Crossing Status: Indicator Found					
UCIP Comments: 04/05/2013 Need to contact ownder to determin					
status of crossing and install signs if appropriate. (DWR UCIP - P.					
Amatya)					
FIELD_STRUCT_DESC: 18-inch steel natural gas pipeline through the					
levee, at an unknown depth. [Additional Reference(s): Sutter-Butte					
Flood Control Agency, Volume 3, As-Built Drawing No. GC-120, Sheet					
58, no reference to any crossings at this location. USACE Sacramento					
O&M Manual 144, August 1955, (Station 1473+60)].					
FS Date: 4/5/2013

WS- USA road marking and floodway area

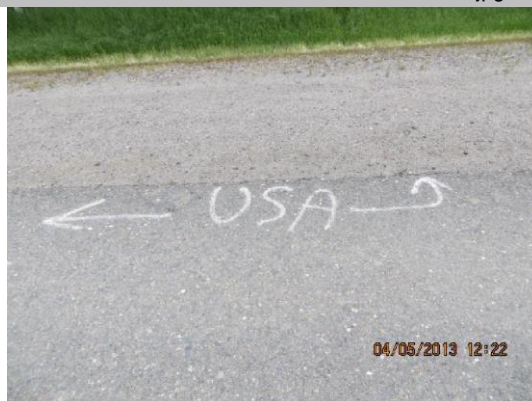
Photo 2 of 3 : UCIP\_FA\_2018\_41887\_19570.jpg

Comment Code						
Inspector Comment						
FS_ID:41887						
DS_ID:18640						
EP_NO: N/A						
Repair Type: Non-Urgent						
Crossing Status: Indicator Found						
UCIP Comments: 04/05/2013 Need to contact ownder to determin						
status of crossing and install signs if appropriate. (DWR UCIP - P.						
Amatya)						
FIELD_STRUCT_DESC: 18-inch steel natural gas pipeline through the						
levee, at an unknown depth. [Additional Reference(s): Sutter-Butte						
Flood Control Agency, Volume 3, As-Built Drawing No. GC-120, Sheet						
58, no reference to any crossings at this location. USACE Sacramento						
O&M Manual 144, August 1955, (Station 1473+60)].						
FS Date: 4/5/2013

WS- USA road marking on pavement

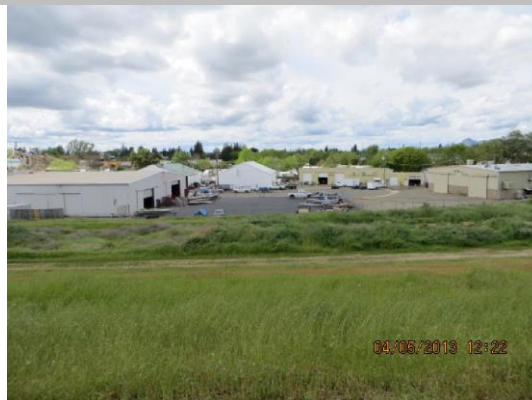
Photo 3 of 3 : UCIP\_FA\_2018\_41887\_19569.jpg

LS- overview. No sign post or indicator found.

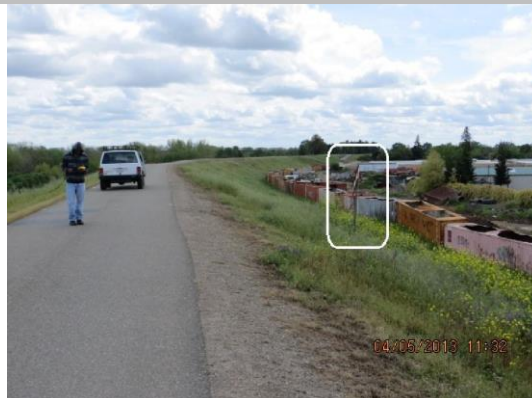
Photo 1 of 2 : UCIP\_FA\_2018\_12092\_19624.jpg

Comment Code						
Inspector Comment						
FS_ID:12092						
DS_ID:17923						
EP_NO: N/A						
Repair Type: Non-Urgent						
Crossing Status: Indicator Found						
UCIP Comments: 04/05/2013 Only a gasoline indicator found on						
LS.Needs gasoline marker also on WS.(DWR UCIP - P. Amatya)						
FIELD_STRUCT_DESC: 16-inch natural gas pipeline of an unknown						
material through the levee, 3.5 feet below the crown. Pipeline protected						
in place as part of the Feather River West Levee Reconstruction						
Project. Marker installed on the landside (LS). [Additional Reference(s):						
DWR Levee Log, 2005. Sutter-Butte Flood Control Agency, Volume 3,						
As-Built Drawing No. C-124, Sheet 62, (Station 1073+41)].						
FS Date: 4/5/2013

LS- overview of gasoline marker on levee slope

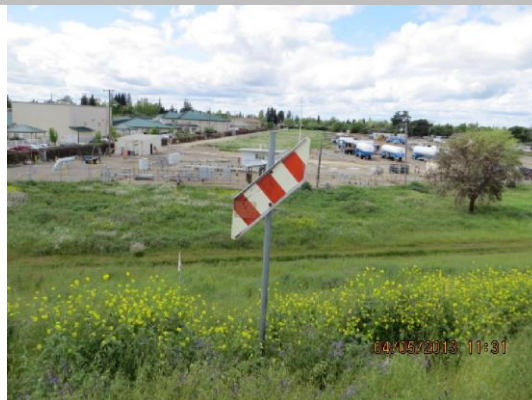
Photo 2 of 2 : UCIP\_FA\_2018\_12092\_19623.jpg

LS- gasoline marker on levee slope

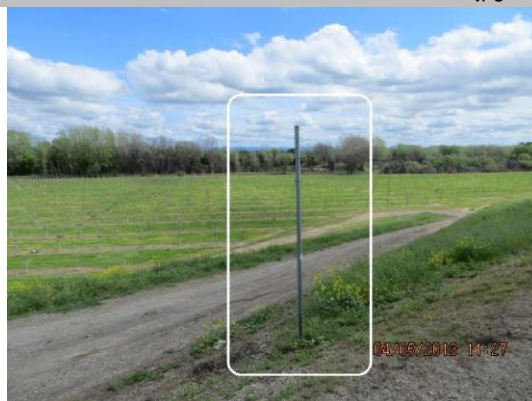
Photo 1 of 3 : UCIP\_FA\_2018\_12104\_19642.jpg

Comment Code						
Inspector Comment						
FS_ID:12104 DS_ID:18644 EP_NO: 17259 Repair Type: Non-Urgent Crossing Status: Indicator Found UCIP Comments: 04/05/2013 Found an indicator only on LS. Needs an indicator also on WS.(DWR UCIP - P. Amatya) FIELD_STRUCT_DESC: *REMOVED* 8.375-inch-wide electrolysis test station (ETS) at a depth of 4 feet was connected to the existing 8-inch steel natural gas pipeline within the waterside (WS) levee toe. Pipeline has been removed as part of the Feather River West Levee Reconstruction Project. [Additional Reference(s): Sutter-Butte Flood Control Agency, Volume 3, As-Built Drawing No. C-124, Sheet 62, (Station 1079+91), no replacement pipe mentioned]. FS Date: 4/5/2013

WS- needs a gasoline indicator.

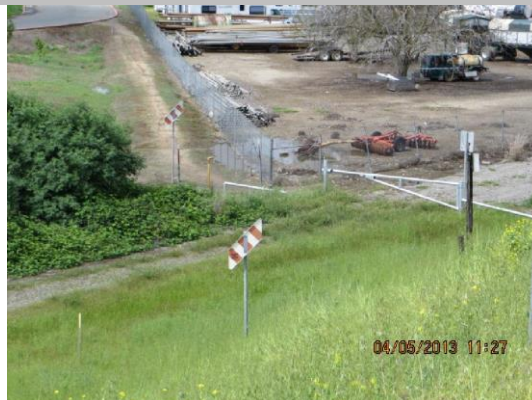
Photo 2 of 3 : UCIP\_FA\_2018\_12104\_19641.jpg

LS- gasoline indicators on levee slope and across.

Comment Code						
Inspector Comment						
FS_ID:12104 DS_ID:18644 EP_NO: 17259 Repair Type: Non-Urgent Crossing Status: Indicator Found UCIP Comments: 04/05/2013 Found an indicator only on LS. Needs an indicator also on WS.(DWR UCIP - P. Amatya) FIELD_STRUCT_DESC: *REMOVED* 8.375-inch-wide electrolysis test station (ETS) at a depth of 4 feet was connected to the existing 8-inch steel natural gas pipeline within the waterside (WS) levee toe. Pipeline has been removed as part of the Feather River West Levee Reconstruction Project. [Additional Reference(s): Sutter-Butte Flood Control Agency, Volume 3, As-Built Drawing No. C-124, Sheet 62, (Station 1079+91), no replacement pipe mentioned]. FS Date: 4/5/2013

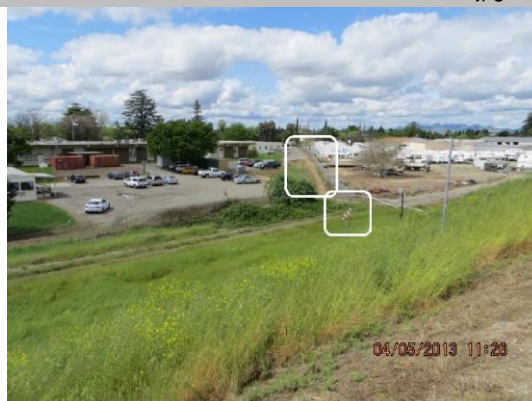
Photo 3 of 3 : UCIP\_FA\_2018\_12104\_19640.jpg

LS- overview of gasoline indicators on levee slope and across.

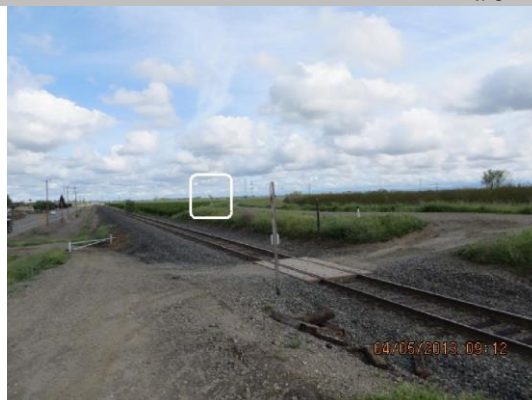
Photo 1 of 2 : UCIP\_FA\_2018\_41888\_19709.jpg

LM Start	16.11	Rating **	M	Issue No.	47
LM End	16.11	Issue Type +	En	Location *	
Category	Supplemental			GPS Latitude/Longitude	
				Start	End
Item	DWR UCIP Field Study			39.168830 °	39.168830 °
				-121.622628 °	-121.622628 °
DWR ID	18645				
Comment Code					
Inspector Comment					
FS_ID:41888					
DS_ID:18645					
EP_NO: 3823					
Repair Type: Non-Urgent					
Crossing Status: Indicator Found					
UCIP Comments: 04/05/2013 Need to contact owner to determine status of crossing and install markers if appropriate. Several lines in area. (DWR UCIP - P. Amatya)					
FIELD_STRUCT_DESC: 8-inch steel natural gas pipeline through the levee and overflow area, 3.3 feet below the crown. (Plans for installation of a steel pipeline through the levee authorized under Permit No. 3823, 1961 - Southern Pacific Pipe Lines, Inc.).					
FS Date: 4/5/2013

Railway and levee crossing and gasoline sign across the railway

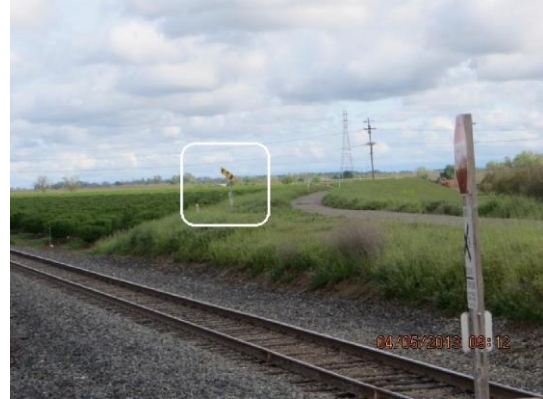
Photo 2 of 2 : UCIP\_FA\_2018\_41888\_19708.jpg

Gasline sign across the railway
